Case History

Application: Steel Support Structure of a Shaft Kiln

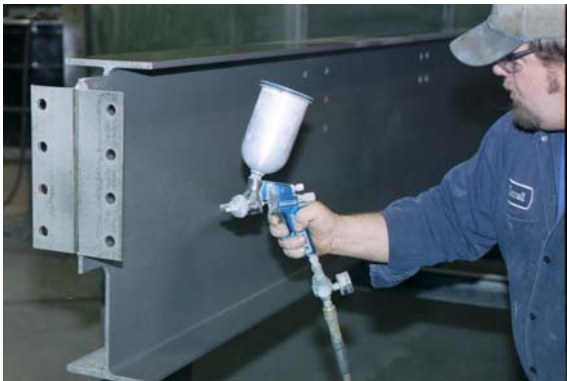
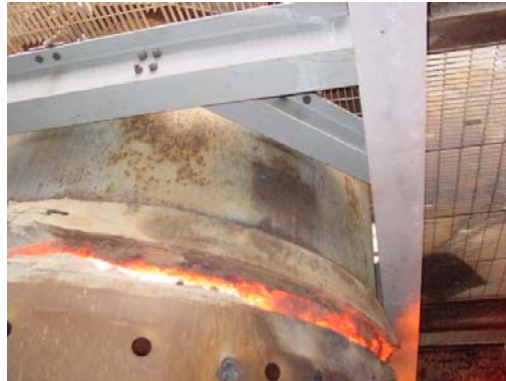
Problem: The support structure of this shaft kiln was beginning to fail (warp and sag) due to flame impingement from the furnace exhaust. Because of the production line configuration, it was impossible to correct the poor design of the supporting structure which led to the failure. The steel structure was therefore reconstructed in its original design using an Emisshield® STG-3 coating to protect it from heat.

Application of Emisshield®: The steel structure was grit blasted to get down to bare metal. The steel was then washed with DURL-LUM 603 to remove grease and adjust the surface pH. Emisshield® STG-3 was applied using a high volume low pressure spray gun. The coating was air dried for 24 hours before the steel was erected.

Results after applying Emisshield®: Temperature measurements were taken and showed the surface temperature to be only 555°F, which is low enough for satisfactory service. Most of the damaging heat from the furnace exhaust was absorbed and re-radiated into the plant atmosphere. The coated steel has been in service for three years.
